Inspection Report

Property Address:

123 Address
Any City, CA

Signature Property Inspections

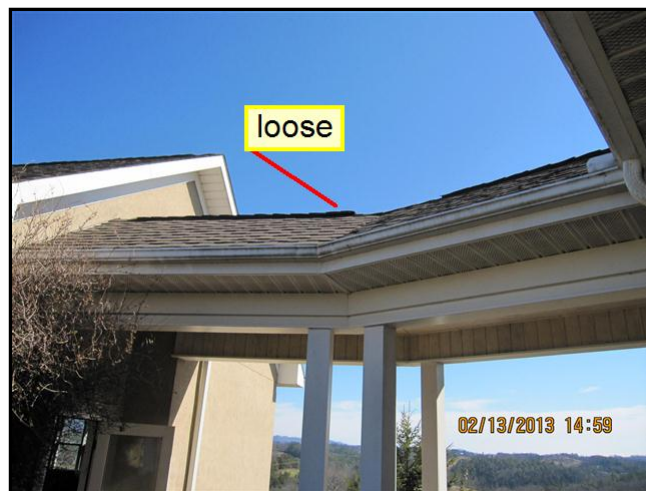
1.2 Picture 1

Ridge vent loose at end above breezeway and needs to be fastened. Nail head used to fasten should be sealed with sealant.

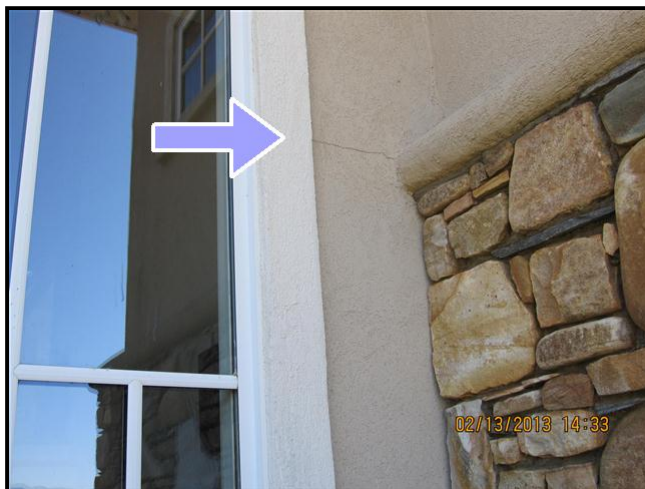
2.0 Picture 1

(1) Some hairline cracks in areas around home. These appear to be typical.

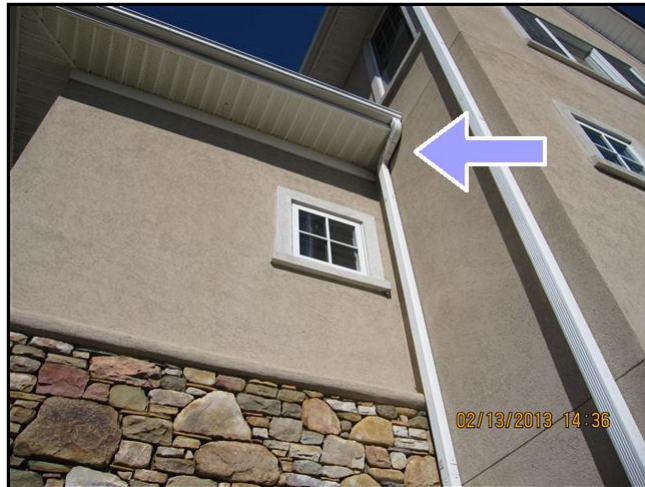
2.0 Picture 3

(2) Bird nest is wedged between downspout elbow and home should be removed and inspect further as animals can damage and allow water to get inside wall.

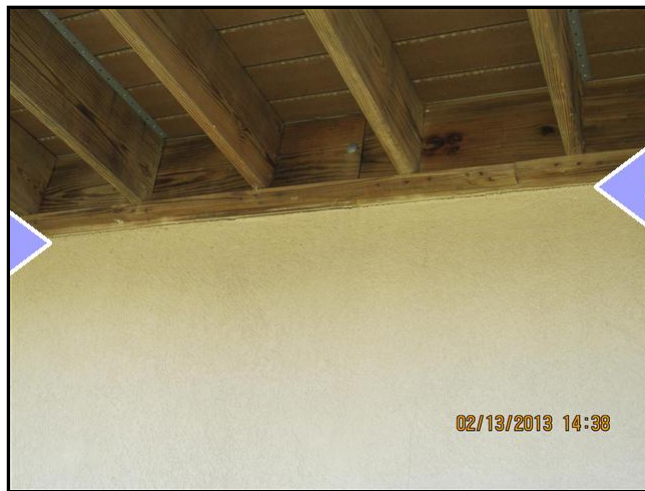
2.0 Picture 4

(3) A common seam where stucco and ledger meet under deck. I recommend silicone caulking to seal.

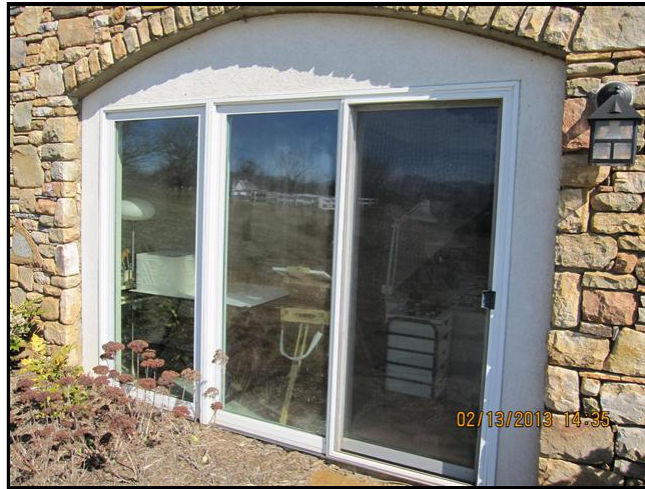
2.1 Picture 1

Glass panel doors/window at right side (facing front) cloudy or seal is broken. Glass panes that have lost their seal (cloudy) can usually be replaced without replacing the entire unit. A qualified contractor should inspect and repair as needed.

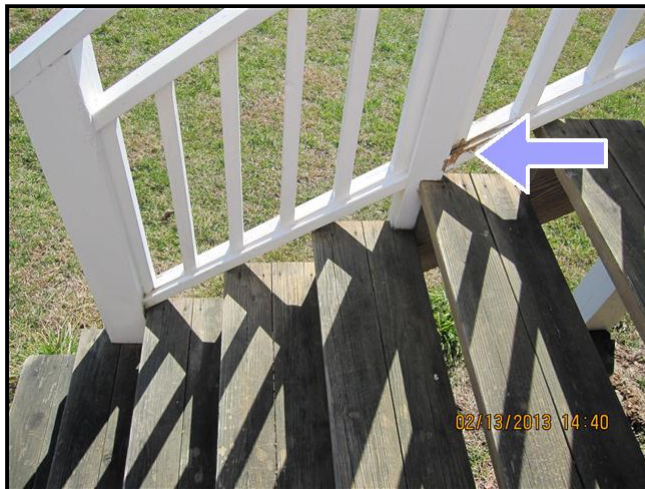
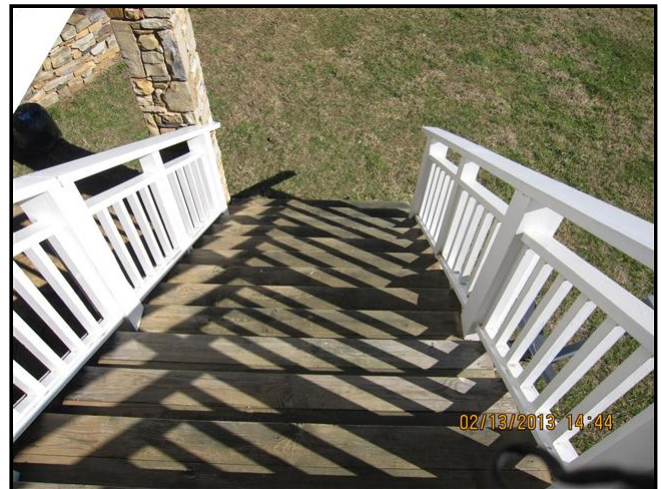
2.3 Picture 1

Bottom rail is soft or deteriorated in one area and other areas weathered. Needs prep and paint. Deck stairs need algae removed with a cleaner and seal with a non skid weather sealant.

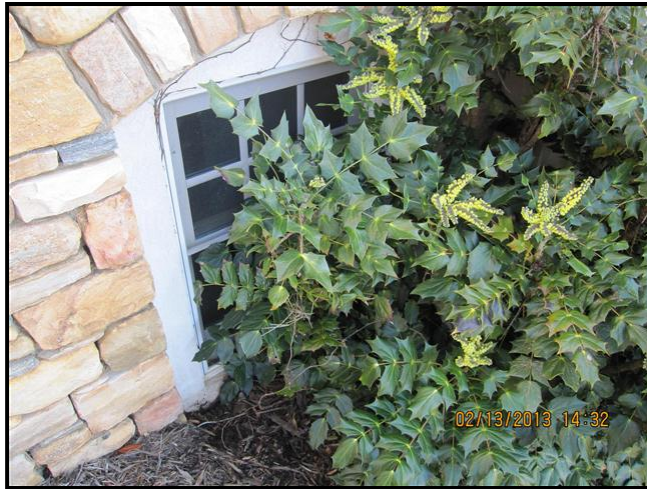
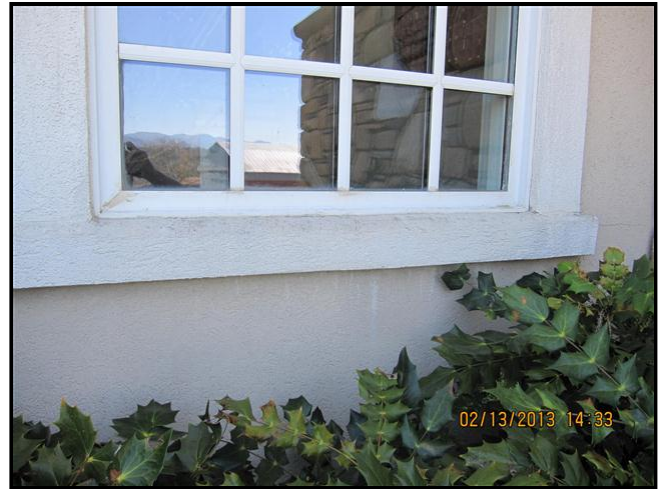
2.4 Picture 1

Thorny bushes or vegetation obstructing access and should be relocated to allow clearance from siding of home

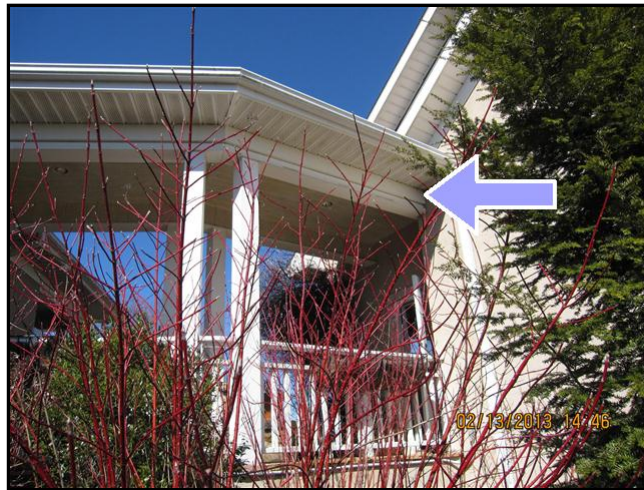
2.5 Picture 1

Some areas need prep and paint along breezeway at top fascia trim (cosmetic).

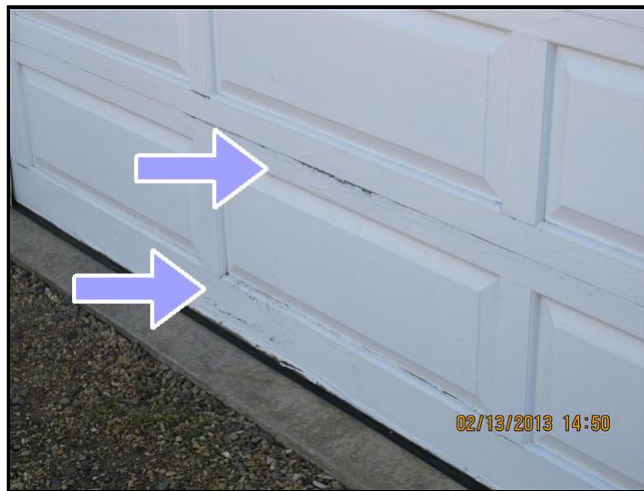
3.3 Picture 1

Weathered needs prep and paint at Garage door.

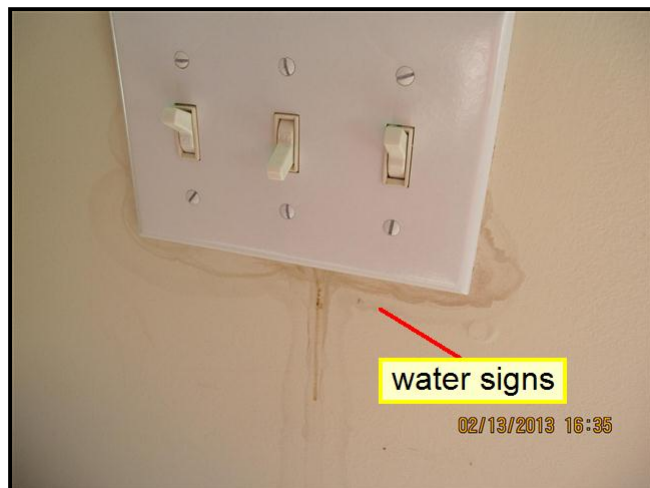
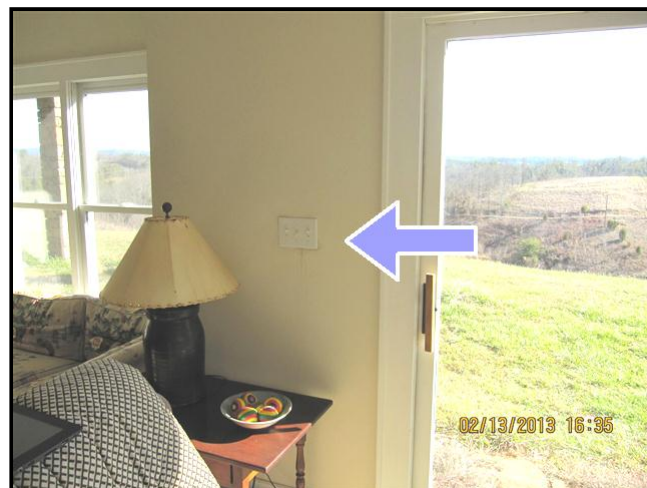
4.1 Picture 1

Wall switch at lower level shows evidence of water getting in from outside? There is a light fixture in relation to this wall switch and perhaps water is getting in there? i recommend further investigation to determine location and correct.

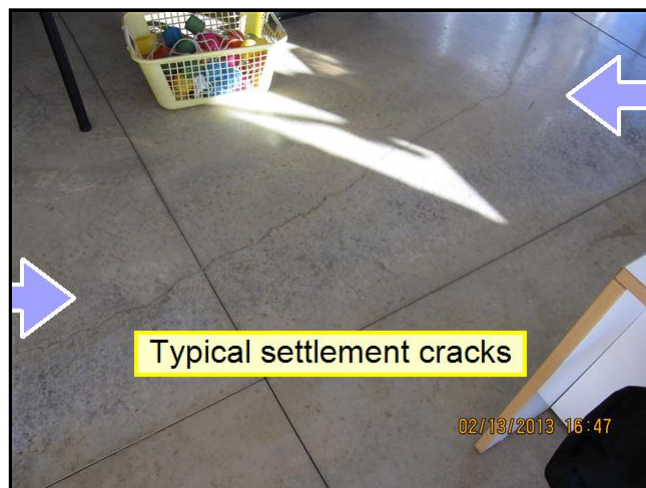
4.2 Picture 1

Lower level concrete has typical settlement cracks. We did not remove area rug or inspect underneath it.

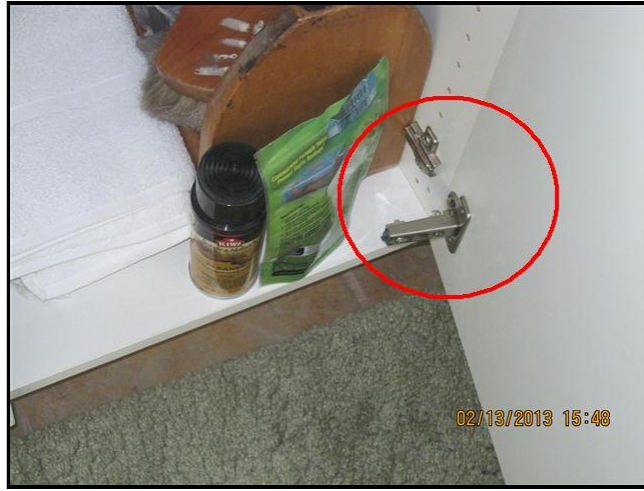
4.4 Picture 1

Hinge needs repair/replace at sink base in master bath.

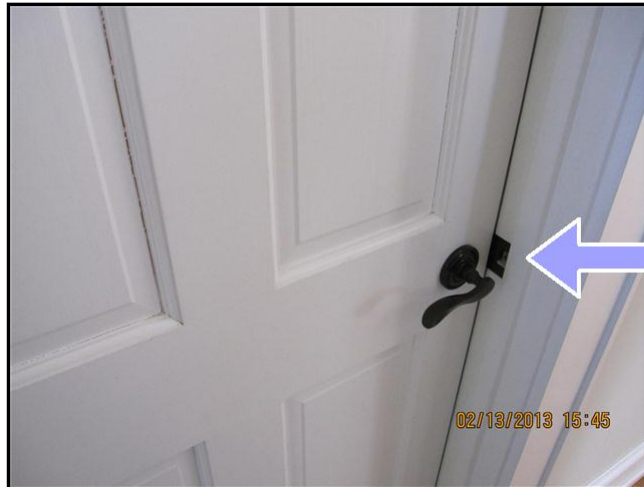
4.5 Picture 1

Master bedroom closet door (His) will not latch easily, needs adjustment

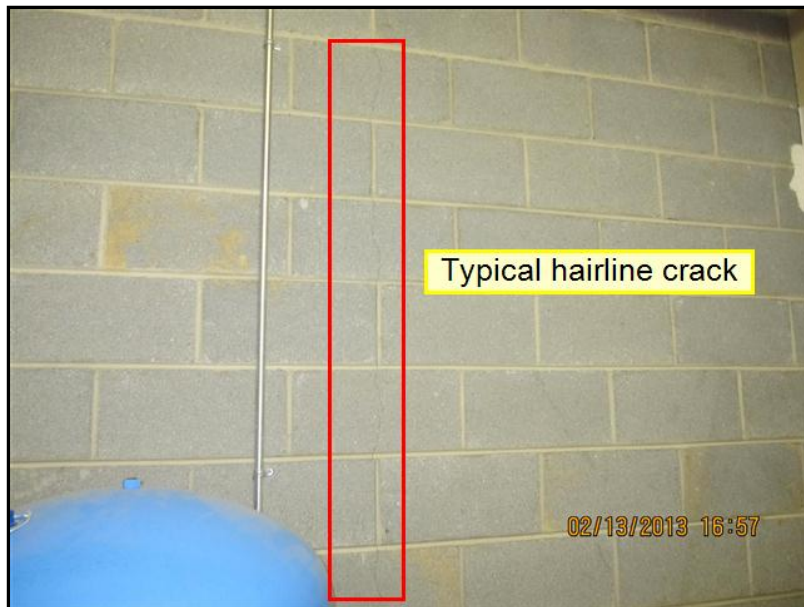
5.1 Picture 1

Hairline cracks in wall (typical).

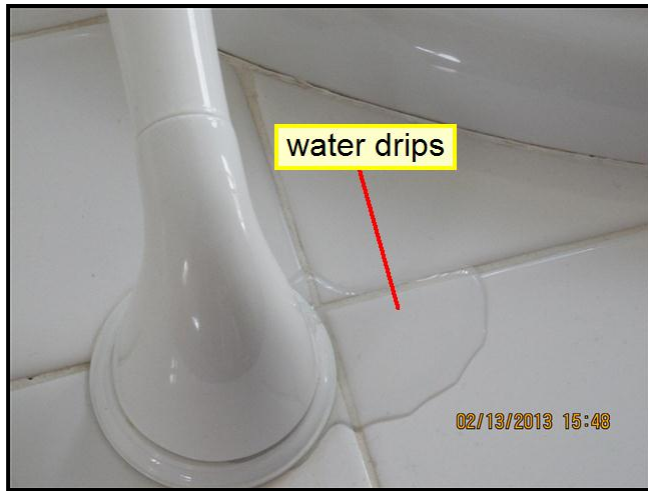
6.1 Picture 1

(1) Water drips from control knob on Jacuzzi brand tub. Also the lever to switch from spout to shower head works but feels weak when moved/turned and I am not sure if it is standard or loose? Recommend a plumber to inspect and repair as needed.

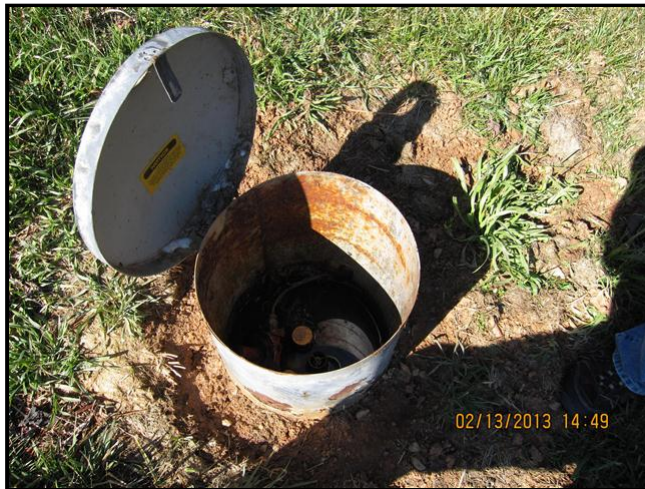
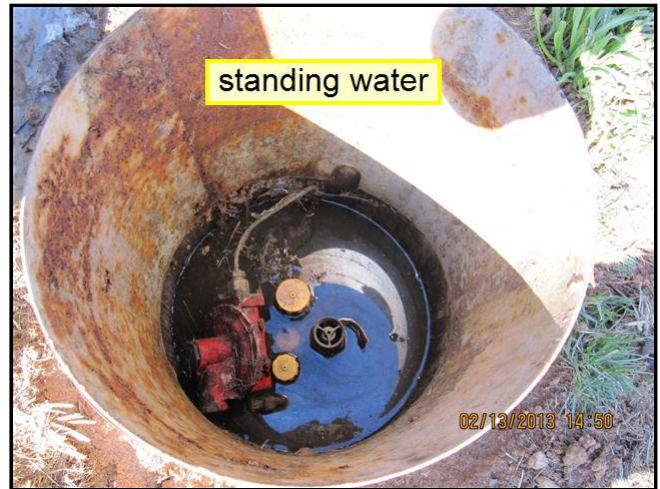
6.4 Picture 1

(1) Standing water should be removed and prevented from occurring at propane valves and meter access.

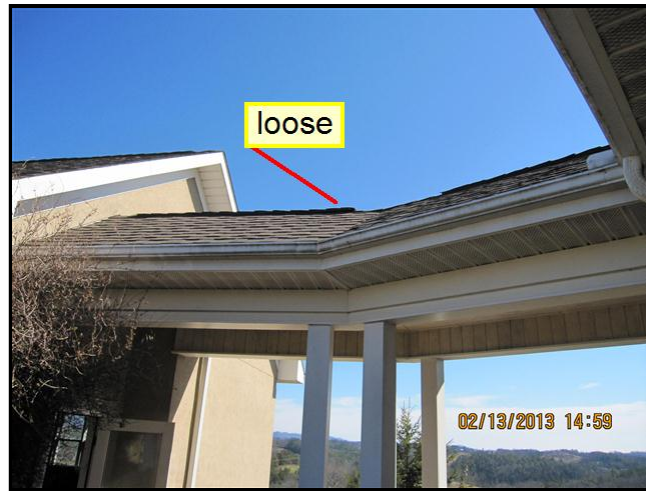
1.2 1

Ridge vent loose at end above breezeway and needs to be fastened. Nail head used to fasten should be sealed with sealant.

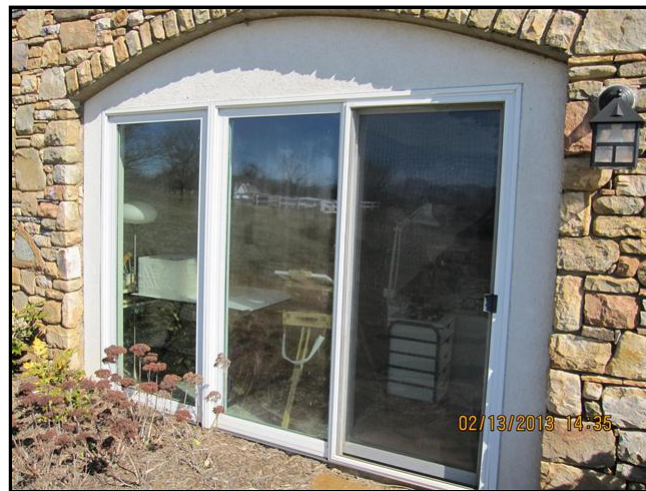
2.1 1

Glass panel doors/window at right side (facing front) cloudy or seal is broken. Glass panes that have lost their seal (cloudy) can usually be replaced without replacing the entire unit. A qualified contractor should inspect and repair as needed.

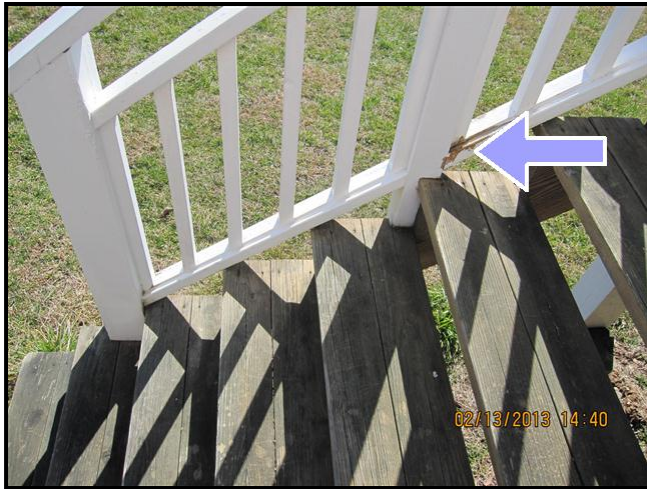
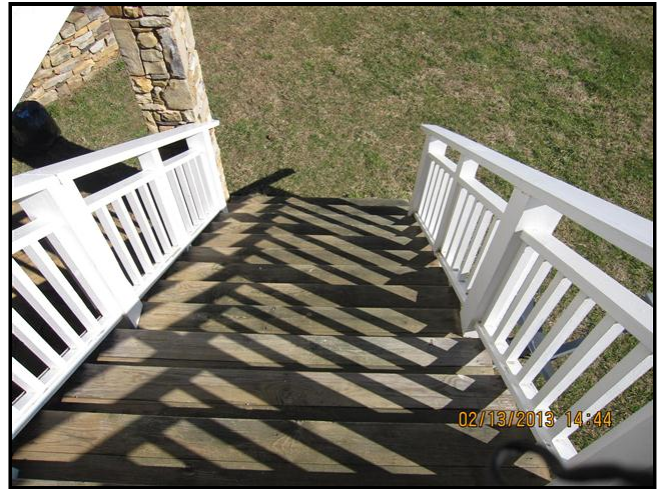
2.3 1

Bottom rail is soft or deteriorated in one area and other areas weathered. Needs prep and paint. Deck stairs need algae removed with a cleaner and seal with a non skid weather sealant.

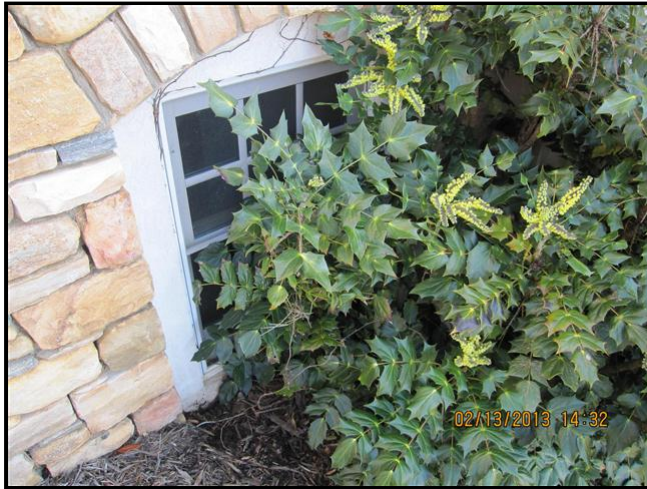
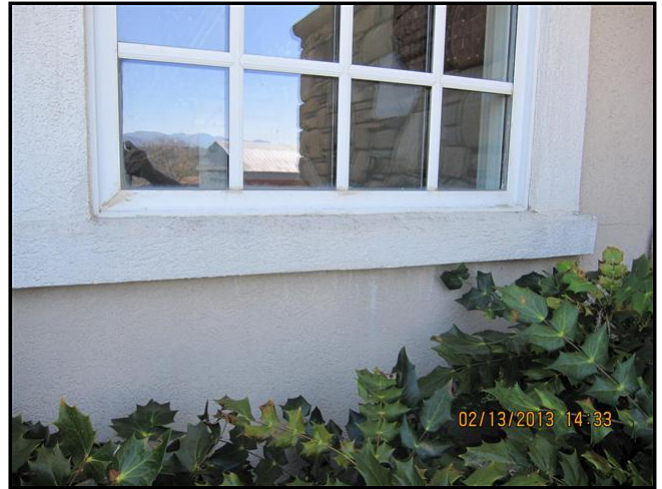
2.4 1

Thorny bushes or vegetation obstructing access and should be relocated to allow clearance from siding of home

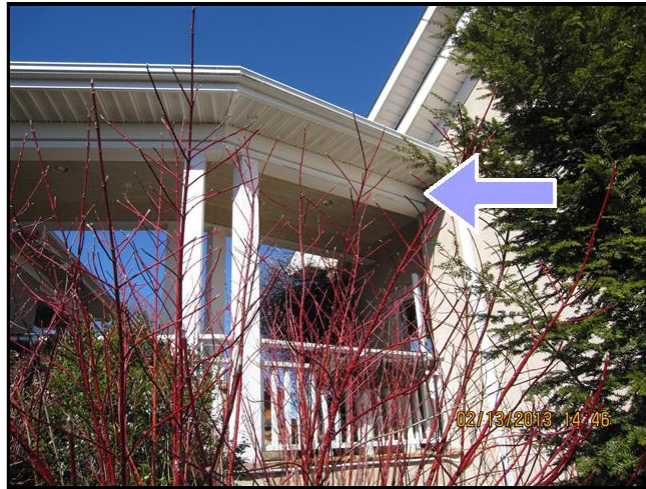
2.5 1

Some areas need prep and paint along breezeway at top fascia trim (cosmetic).

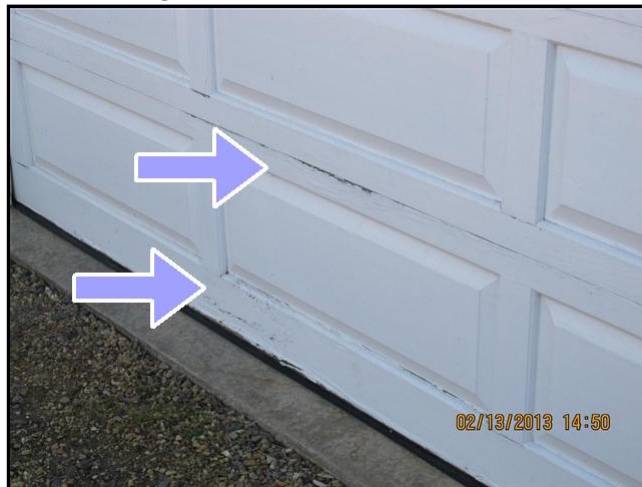
3.3 1

Weathered needs prep and paint at Garage door.

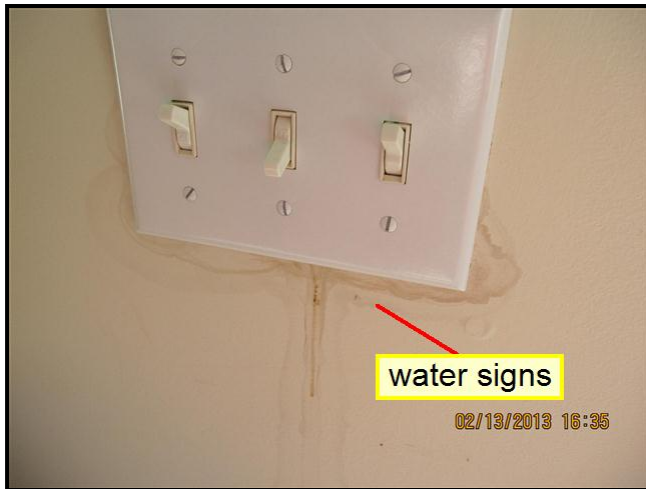
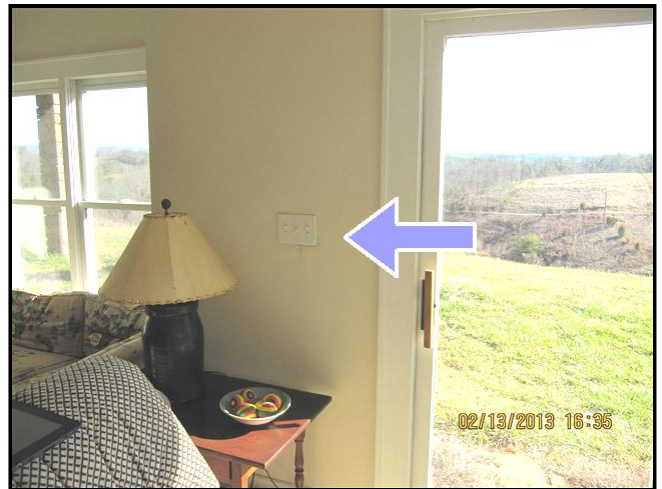
4.1 1

Wall switch at lower level shows evidence of water getting in from outside? There is a light fixture in relation to this wall switch and perhaps water is getting in there? i recommend further investigation to determine location and correct.

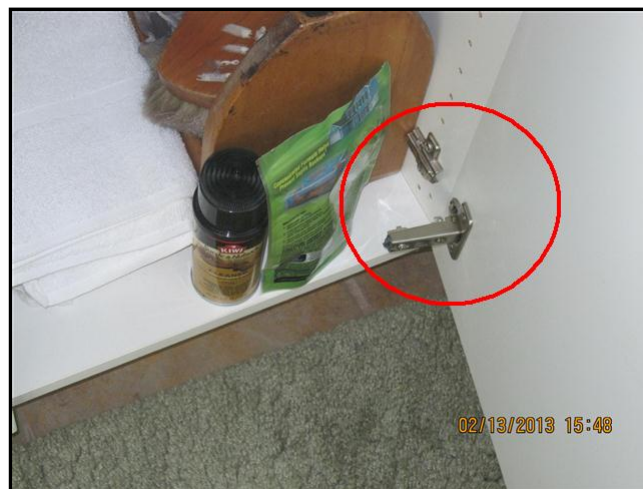
4.4 1

Hinge needs repair/replace at sink base in master bath.

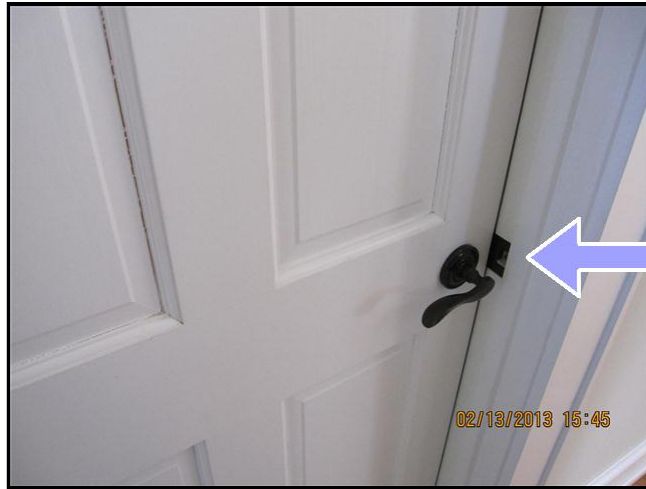
4.5 1

Master bedroom closet door (His) will not latch easily, needs adjustment

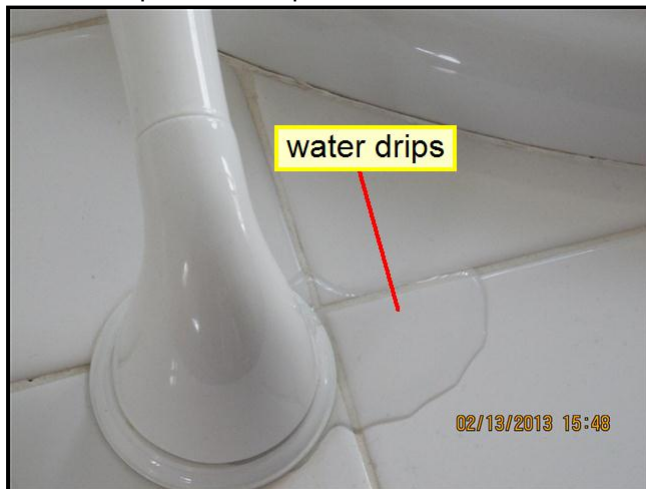
6.1 1

(1) Water drips from control knob on Jacuzzi brand tub. Also the lever to switch from spout to shower head works but feels weak when moved/turned and I am not sure if it is standard or loose? Recommend a plumber to inspect and repair as needed.

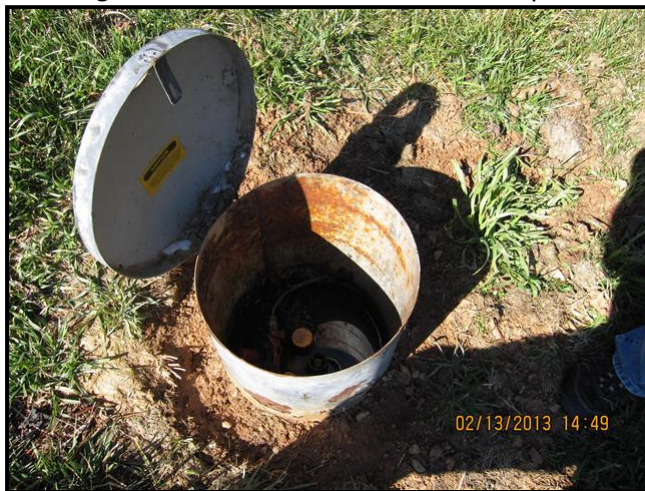
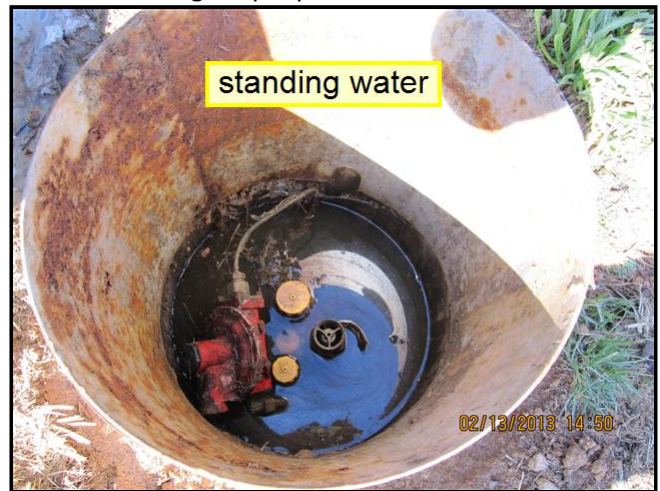
6.4 1

(1) Standing water should be removed and prevented from occurring at propane valves and meter access.

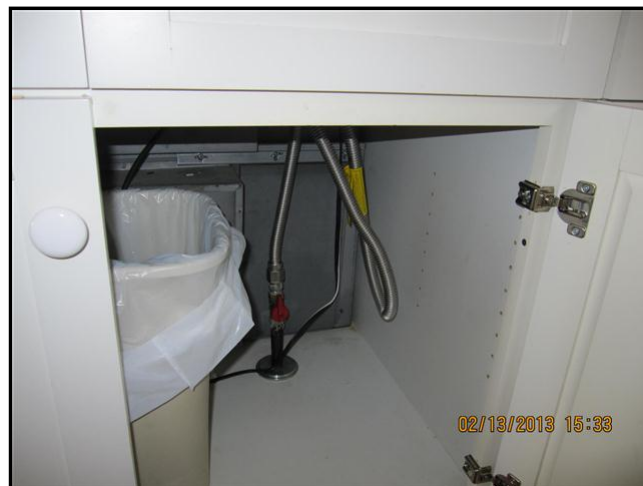
6.4 3

(2) Gas odor detected under range in kitchen and also upon entering into Equipment room downstairs where LP gas water heater is located. Note, there is a fresh air pipe connecting the equipment room to the outside air. Some energy pros may suggest that a mechanical fan would be more energy efficient than the passive vent installed.
